Get the latest updates on the renovation of Mayville State's historic Old Main! Follow progress, upcoming projects, and more as PCL/Community Contractors work to preserve its legacy and shape its future.

PROGRESS UPDATES

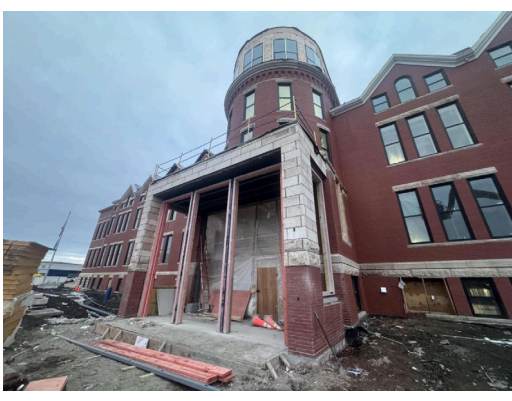
North Entry: Stonework is complete, and a final cleaning will remove grout haze and bring out the full color and detail of the stone.

- Exterior:** The North Entry stone installation is complete, giving a finished look to one of the building's primary access points and enhancing both durability and appearance.

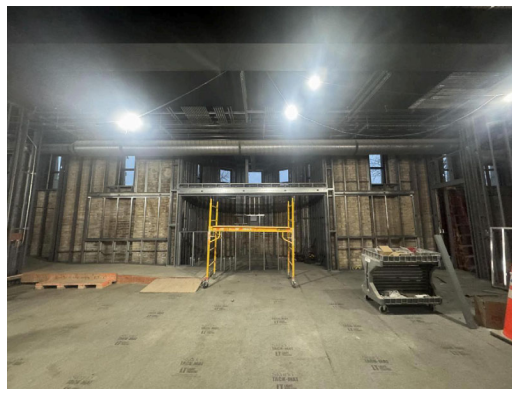
Theater Sound Booth: Framing complete. This space will house audio and lighting controls, serving as the operational hub for performances and events.
